### **Cladding Deflection Evaluation for Wayne Building Products Lux Panel**

# Cladding Deflection Evaluation for Wayne Building Products Lux Panel Final Client Report

A1-008208-01.1

4 April 2016

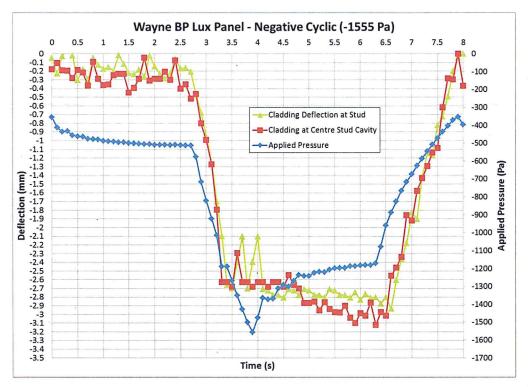
Figure 6: Representative cladding deflection test results during the negative cyclic applied pressure.

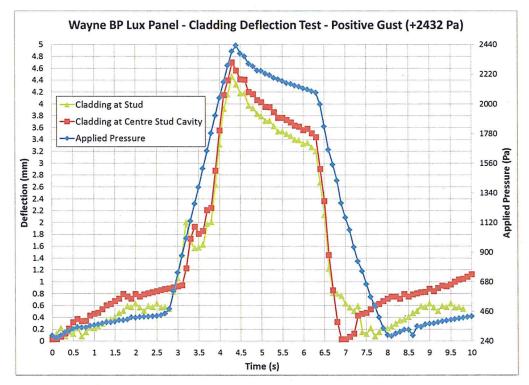
Figure 7: Representative cladding deflection profile during a positive gust loading

locations. Visual and measurement results of the cladding after testing showed that no permanent deterioration or fracture of the cladding occurred during testing. The measured deflection results showed that the maximum cladding deflection during testing was 4.70mm. It should be noted that although the cladding suffered no permanent deflection or visually apparent degradation during testing, this was not the case for the steel studs. During negative load testing the steel studs on one side of the specimen buckled at their center, and subsequently required support of horizontal plywood strapping to complete the cladding deflection testing.

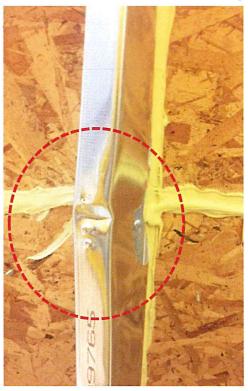
During the portion of the test where negative cyclic loads acted on the test specimen, the steel studs on one side of the specimen buckled in their center height at approximately -800 Pa pressure. To complete the cladding deflection test, these studs were thereafter reinforced with plywood horizontal strapping. As the purpose of this evaluation was determining cladding deflection under loads, and not deflections of the test specimen, no assumptions are made regarding the performance of this wall configuration under field loading conditions. However, care should be taken to ensure that the steel stud gauge is properly selected for the expected wind loads in a full scale wall design. Photos of the buckled steel studs and plywood strapping that were used in the test are shown in Appendix B. Through visual observation the buckled studs did not have any effect on the cladding.

Figure 9: Photo of one buckled stud. This occurred during the negative cycling at approximately -800Pa.

Care should be taken when using this wall configuration in the field to ensure that the stud gauges are properly sized for the intended use.

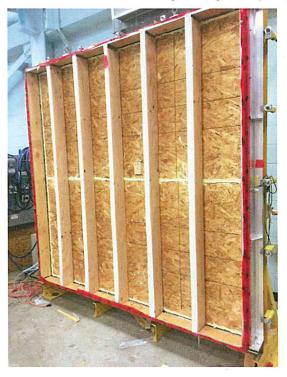
Figure 10: The buckled studs were straightened and reinforced with 3/4in plywood strapping so that the cladding deflection tests could be completed.
